Water and Wastewater Plant Improvements Projects

October 3, 2014

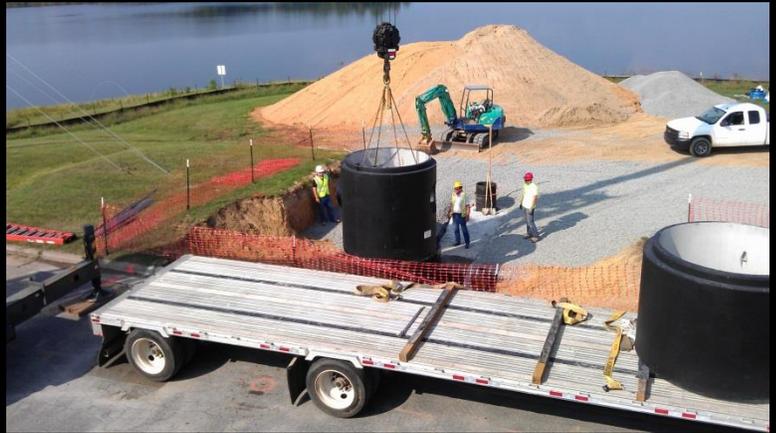
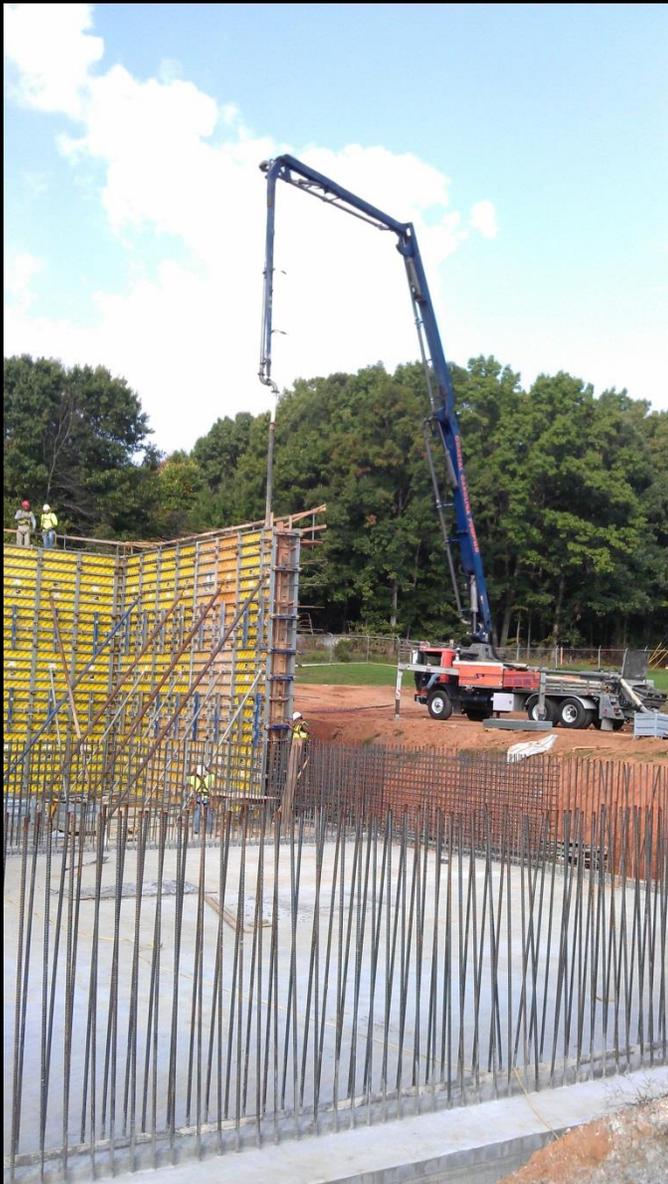
Work continues at a fast pace at the water and sewer plant due to the schedule and the favorable construction weather over the past several weeks. Actual construction at the water plant is now underway as the Contractor prepares the foundation for the future pretreatment tank. On October 2nd the Contractor set the 6' manhole into place which will become the vault needed to install the new chlorine injection ports on the raw water line entering the treatment train at the plant.

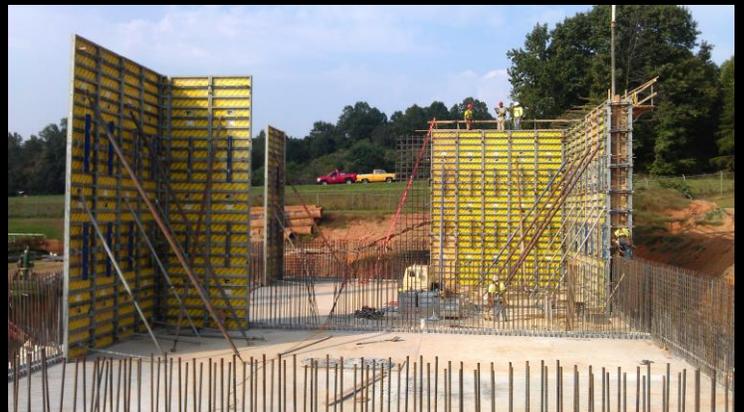
Over at the wastewater plant, work is underway on many fronts. The most obvious construction underway is the preparation and execution of the concrete forming and placement of the walls for the future twin digesters. The digesters are two concrete, partially buried, tanks each of which will hold ½ million of wastewater for treatment.

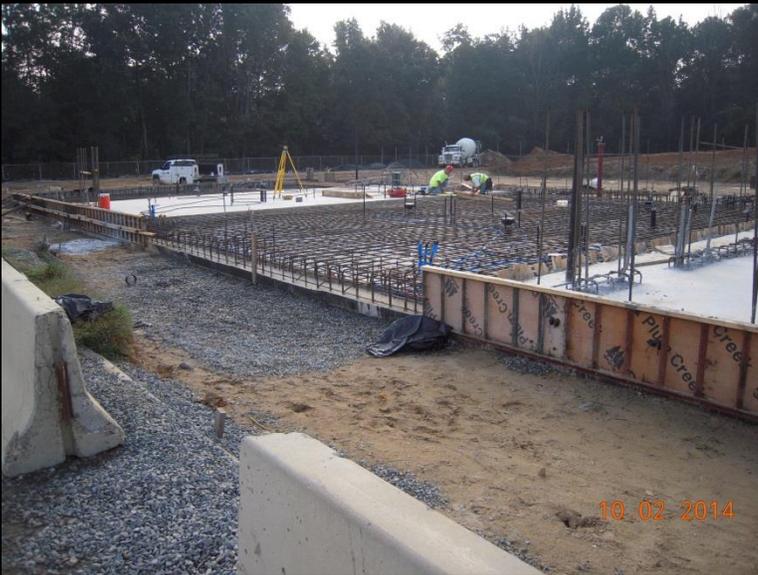
The construction of the walls is a critical component of the overall work. The contractor must first place the steel reinforcing in the proper location and secure it so that it doesn't move as the forms are filled with concrete. The forms themselves are rented on an as need basis and used over and over. In order to *place* the concrete, a concrete pumper truck is used to direct the concrete into the form from the bottom up. Contractors use mechanical vibrators to consolidate the concrete and help reduce the occurrence of voids and other defects in the final product.
